**THE EFFECTS OF ENVIRONMENT ON THE INTERLAMINAR SHEAR
PERFORMANCE OF AN OXIDE/OXIDE CERAMIC MATRIX COMPOSITE AT
ELEVATED TEMPERATURE**

THESIS

AFIT/GAE/ENY/07-J11

AIR FORCE INSTITUTE OF TECHNOLOGY

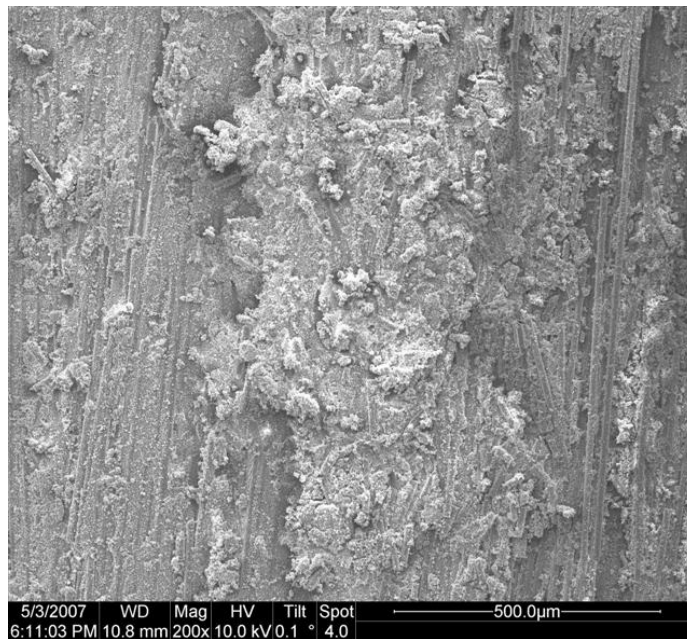
Figure 149: Fracture surface of the N720/A specimen tested in -6.5 MPa creep in air at 1200°C .

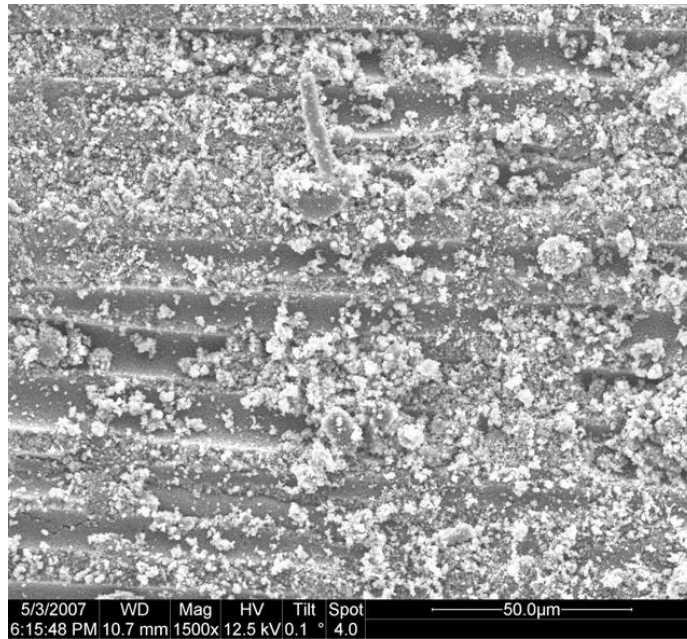
Figure 150: Fracture surface of the N720/A specimen tested in –6.5 MPa creep in air at 1200°C.

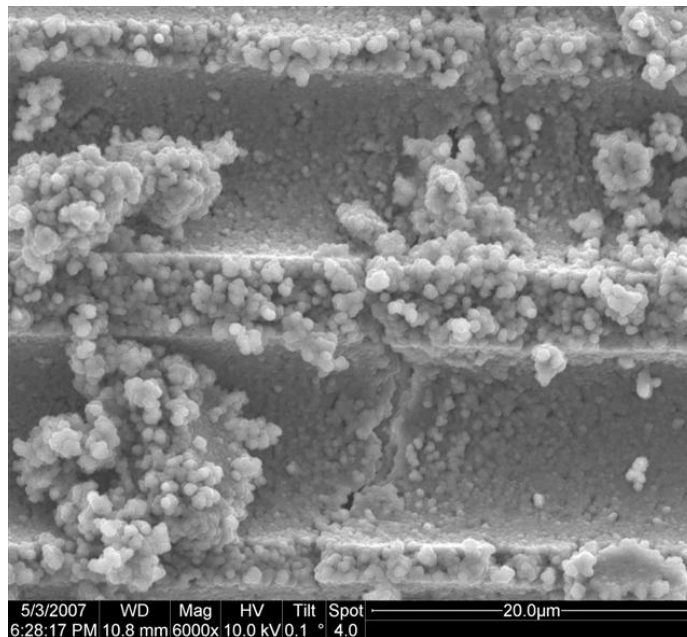
Figure 151: Fracture surface of the N720/A specimen tested in –6.5 MPa creep in air at 1200°C.

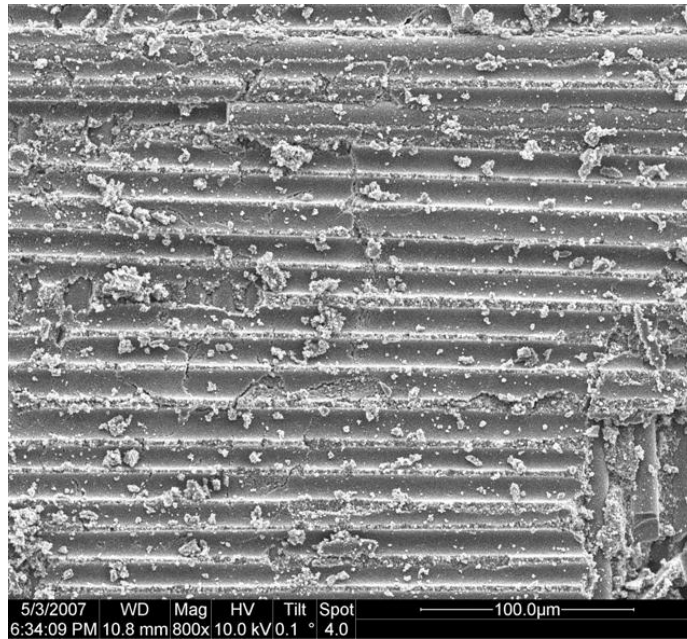
Figure 152: Fracture surface of the N720/A specimen tested in -6.5 MPa creep in air at 1200°C .

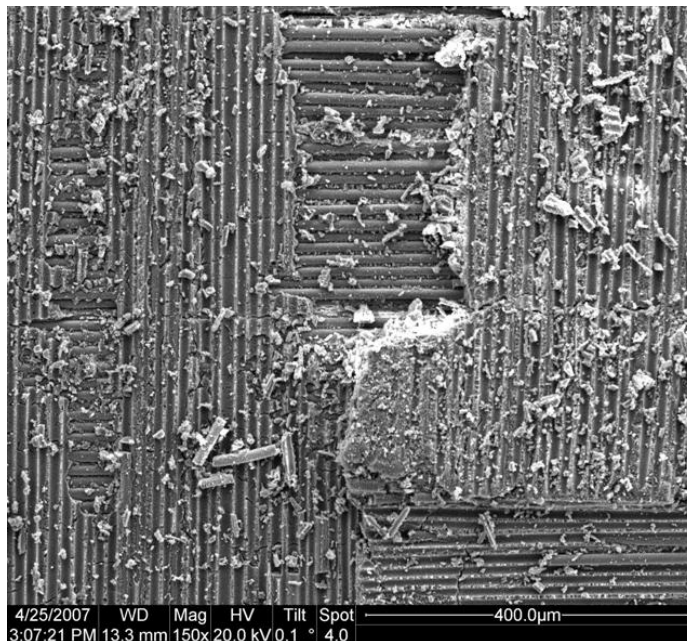
Figure 153: Fracture surface of the N720/A specimen tested in -6.5 MPa creep in steam at 1200°C .

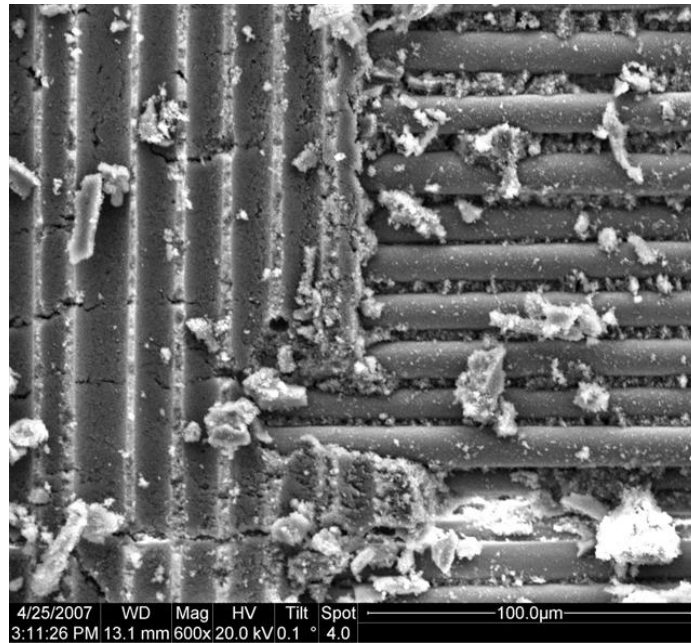
Figure 154: Fracture surface of the N720/A specimen tested in –6.5 MPa creep in steam at 1200°C.

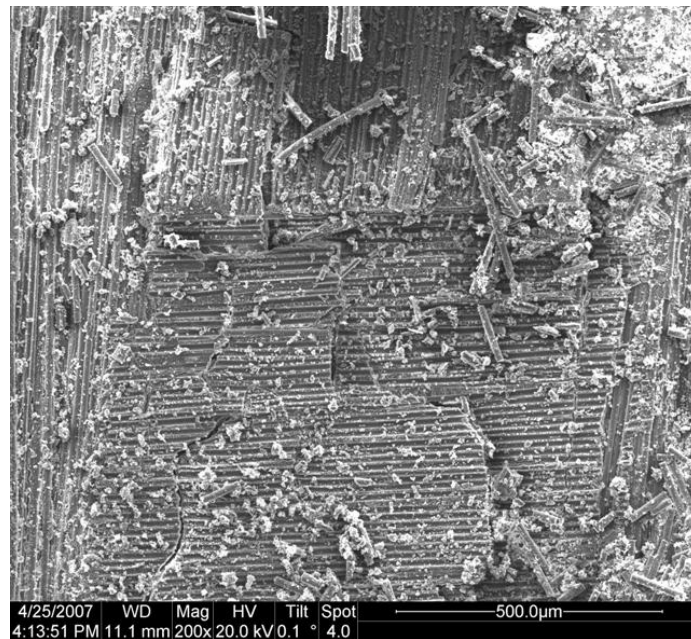
Figure 155: Fracture surface of the N720/A specimen tested in –6.5 MPa creep in steam at 1200°C.

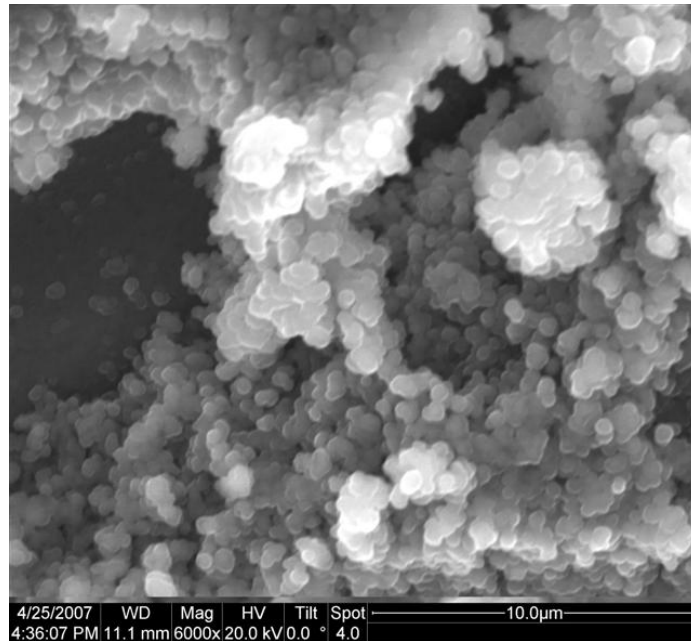
Figure 156: Fracture surface of the N720/A specimen tested in –6.5 MPa creep in steam at 1200°C.

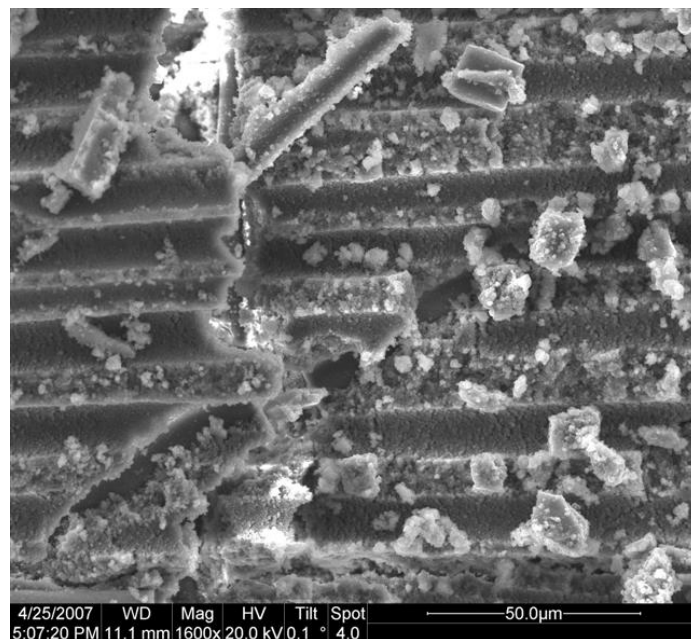
Figure 157: Fracture surface of the N720/A specimen tested in –6.5 MPa creep in steam at 1200°C.

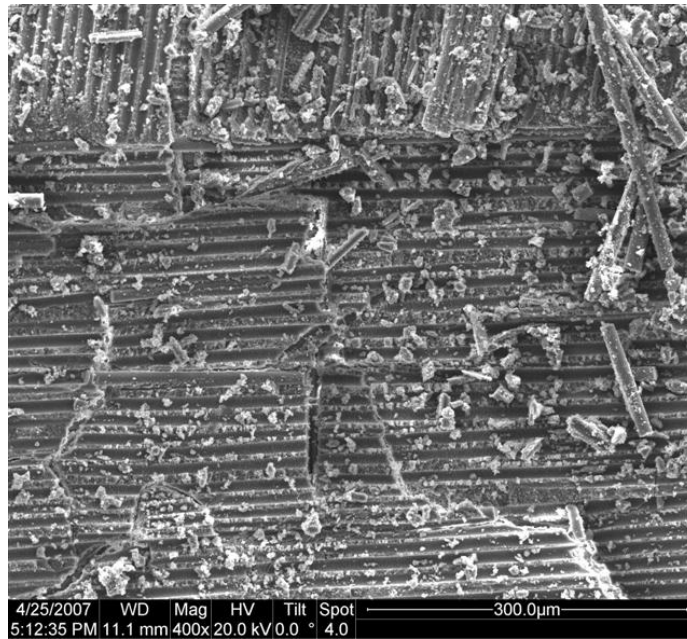
Figure 158: Fracture surface of the N720/A specimen tested in –6.5 MPa creep in steam at 1200°C.

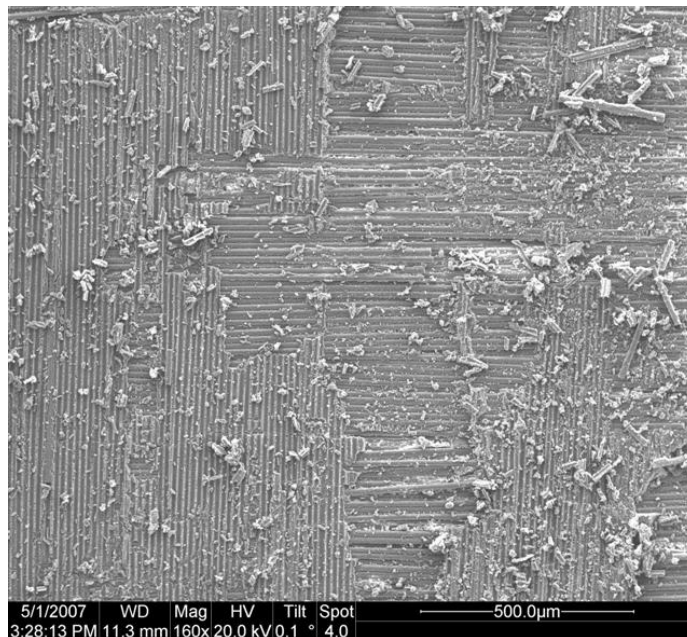
Figure 159: Fracture surface of the N720/A specimen tested in –6.5 MPa creep in steam at 1200°C.

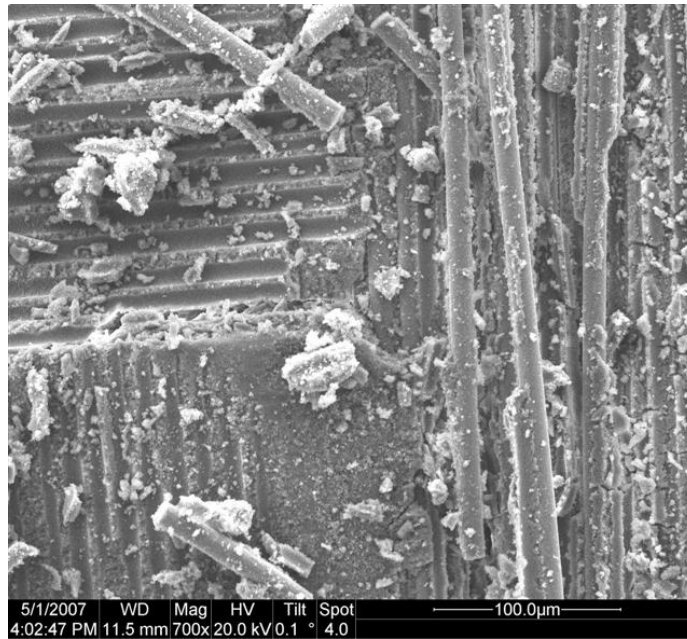
Figure 160: Fracture surface of the N720/A specimen tested in –6.5 MPa creep in steam at 1200°C.

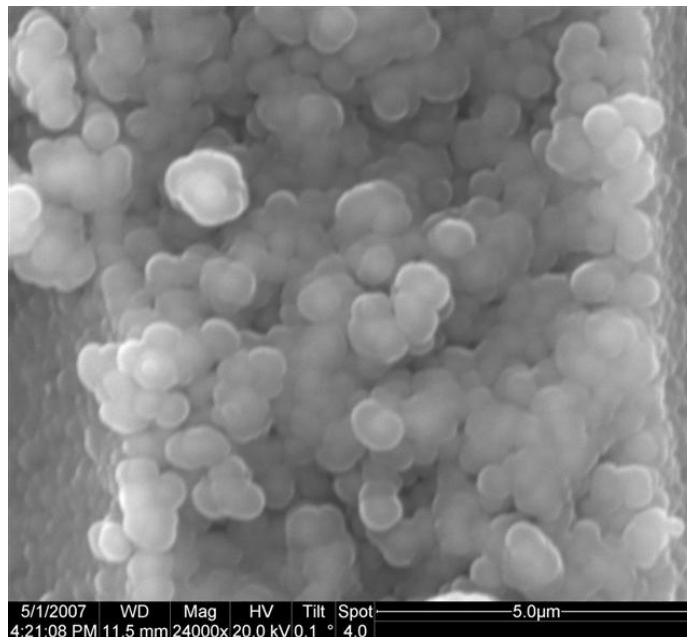
Figure 161: Fracture surface of the N720/A specimen tested in –6.5 MPa creep in steam at 1200°C.

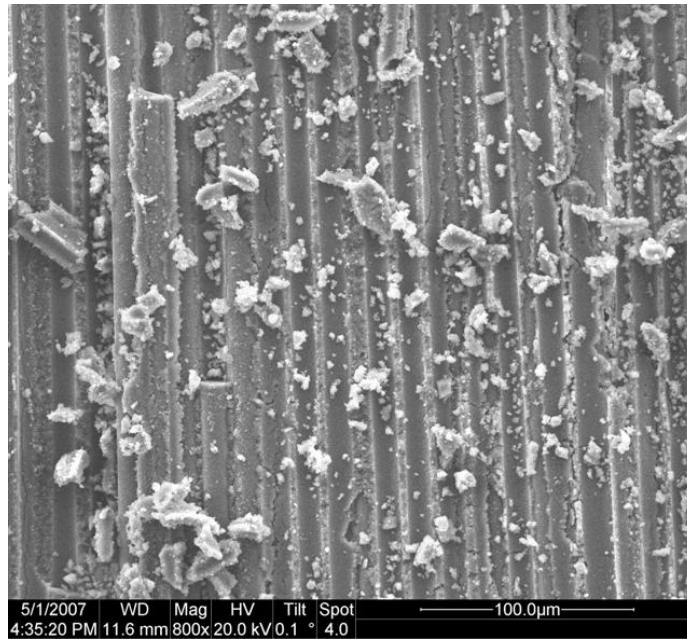
Figure 162: Fracture surface of the N720/A specimen tested in –6.5 MPa creep in steam at 1200°C.

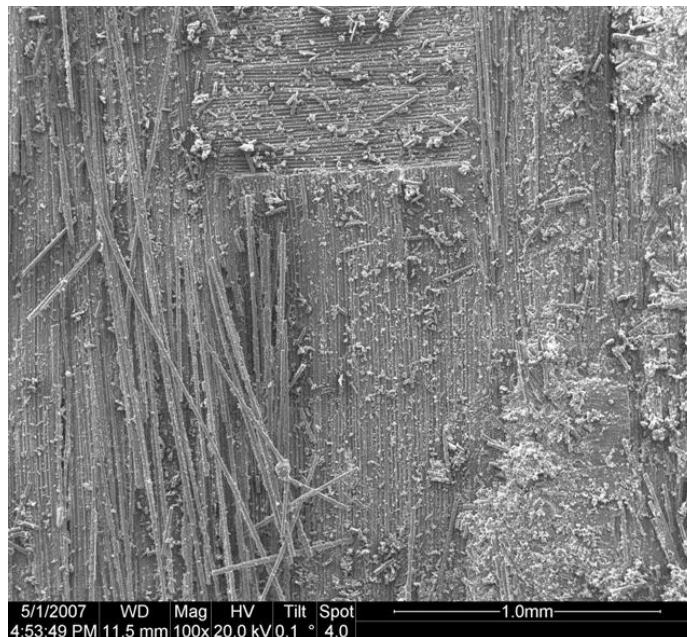
Figure 163: Fracture surface of the N720/A specimen tested in –6.5 MPa creep in steam at 1200°C.

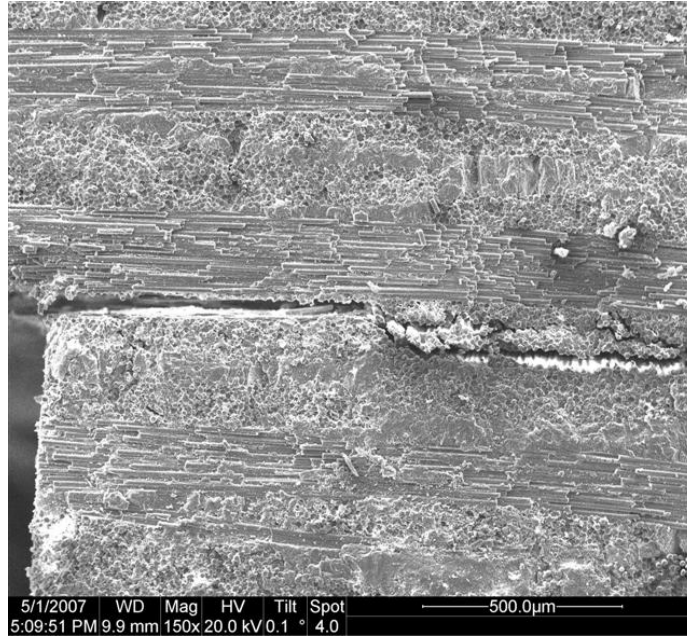
Figure 164: Side of the fracture surface of the N720/A specimen tested in –6.5 MPa creep in steam at 1200°C.

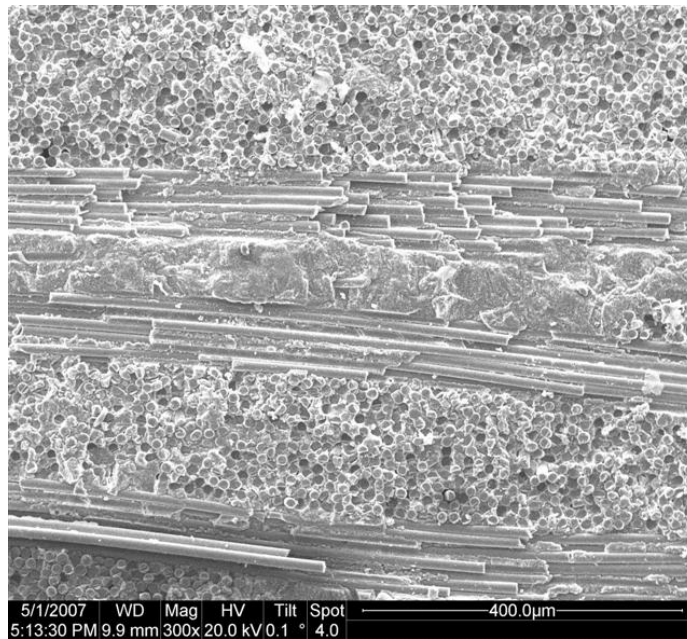
Figure 165: Side of the fracture surface of the N720/A specimen tested in –6.5 MPa creep in steam at 1200°C.

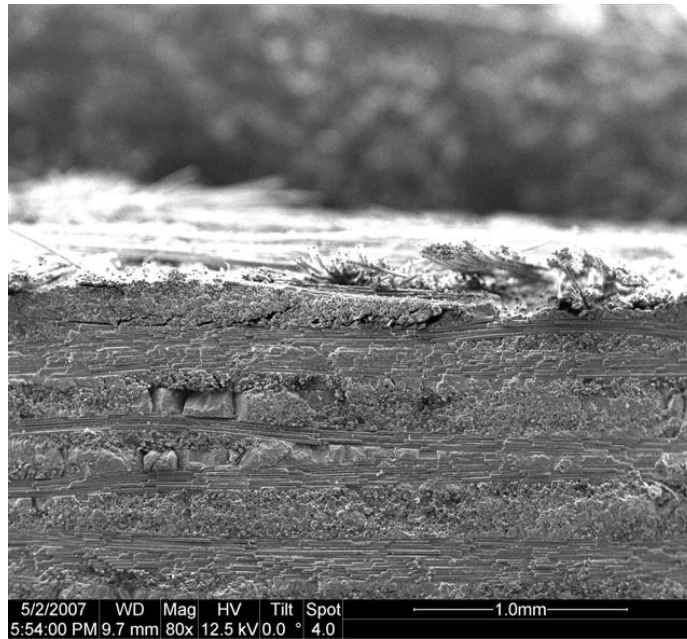
Figure 166: Side of the fracture surface of the N720/A specimen tested in –6.5 MPa creep in steam at 1200°C.

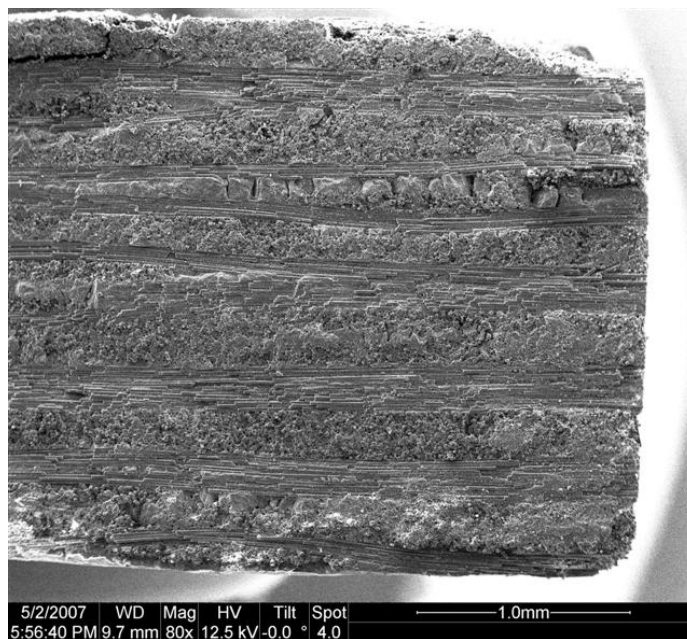
Figure 167: Side of the fracture surface of the N720/A specimen tested in –6.5 MPa creep in steam at 1200°C.

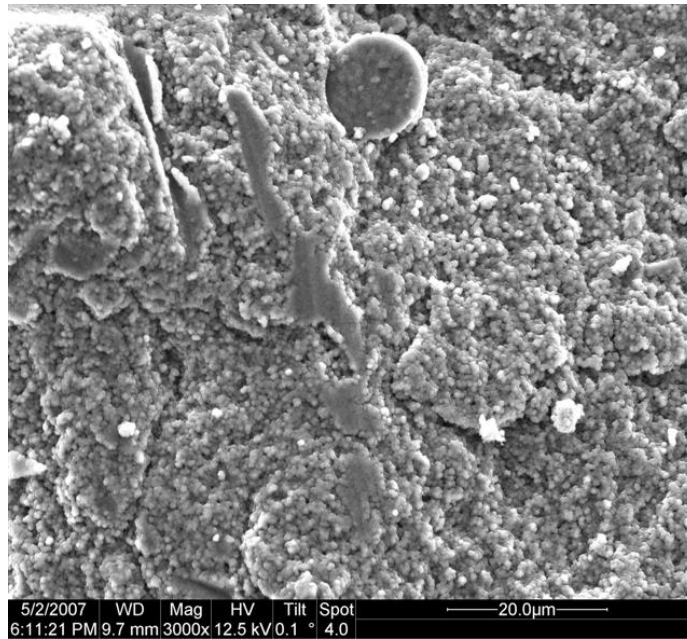
Figure 168: Side of the fracture surface of the N720/A specimen tested in –6.5 MPa creep in steam at 1200°C.

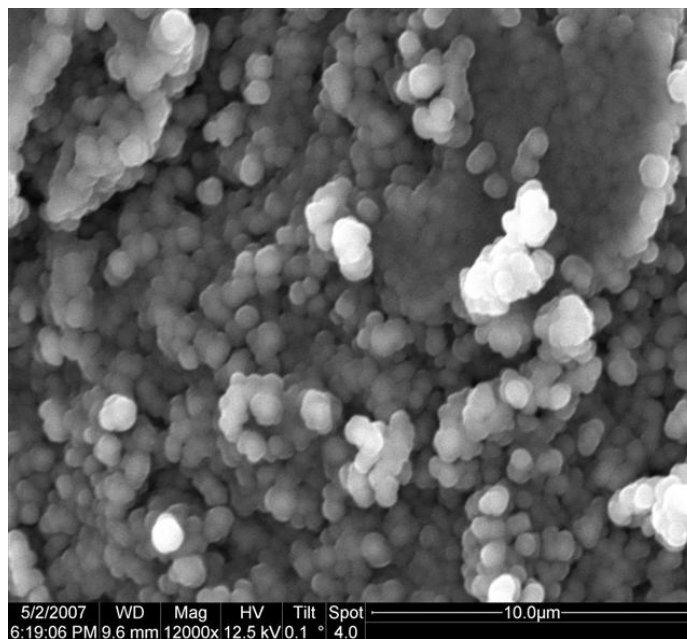
Figure 169: Side of the fracture surface of the N720/A specimen tested in –6.5 MPa creep in steam at 1200°C.

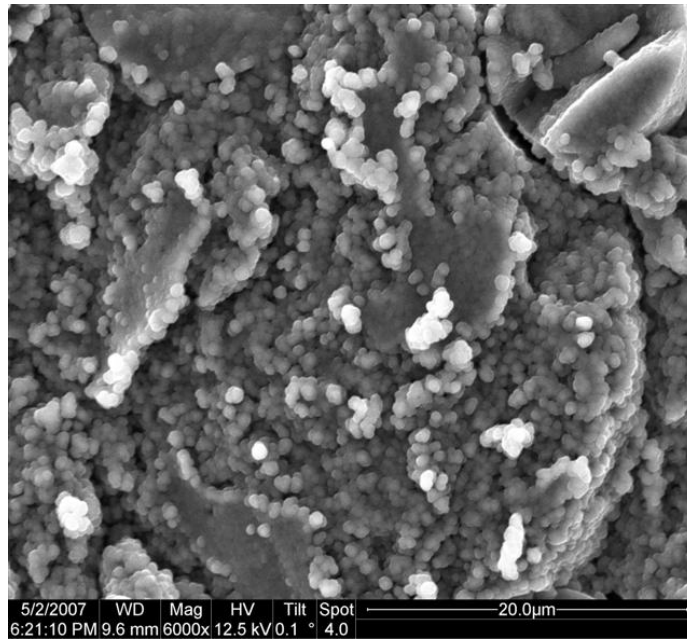
Figure 170: Side of the fracture surface of the N720/A specimen tested in –6.5 MPa creep in steam at 1200°C.

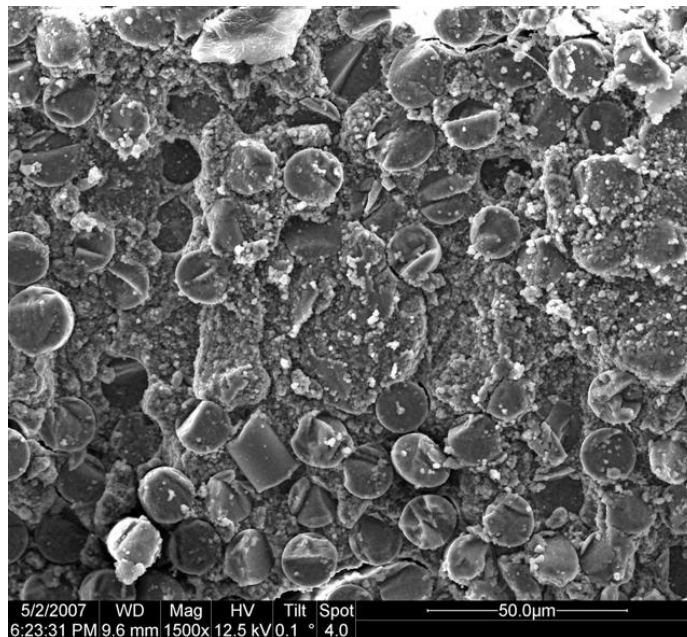
Figure 171: Side of the fracture surface of the N720/A specimen tested in –6.5 MPa creep in steam at 1200°C.

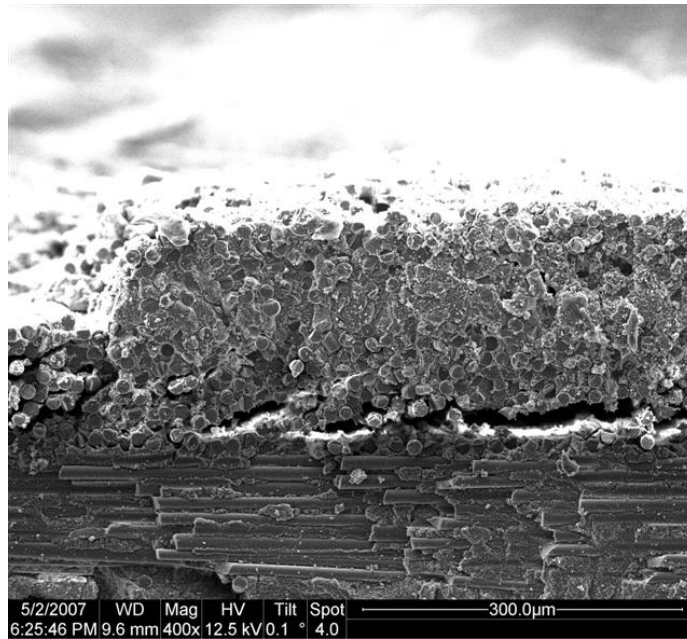
Figure 172: Side of the fracture surface of the N720/A specimen tested in –6.5 MPa creep in steam at 1200°C.

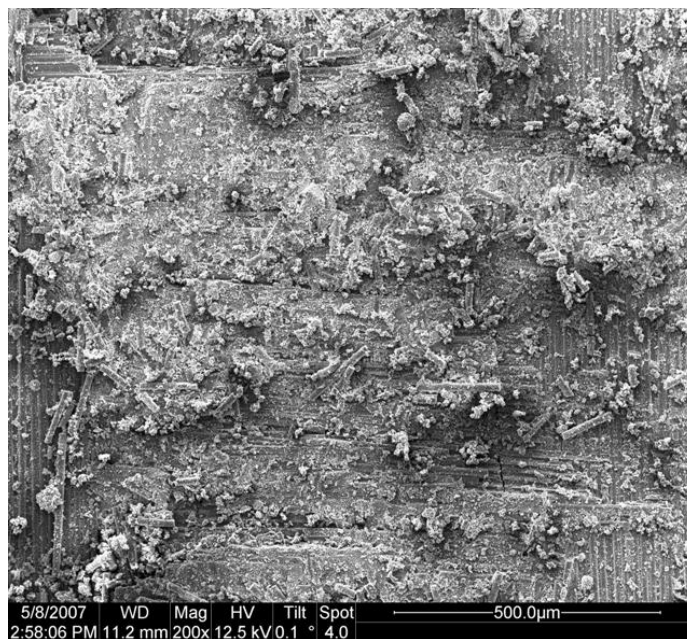
Figure 173: Fracture surface of the N720/A specimen tested in –6.5 MPa creep in steam at 1200°C.

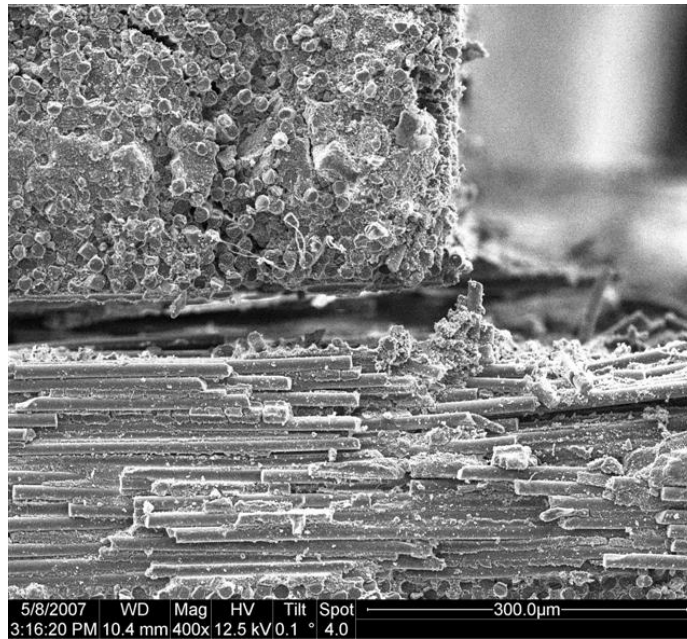
Figure 174: Side of the fracture surface of the N720/A specimen tested in -6.5 MPa creep in steam at 1200°C.

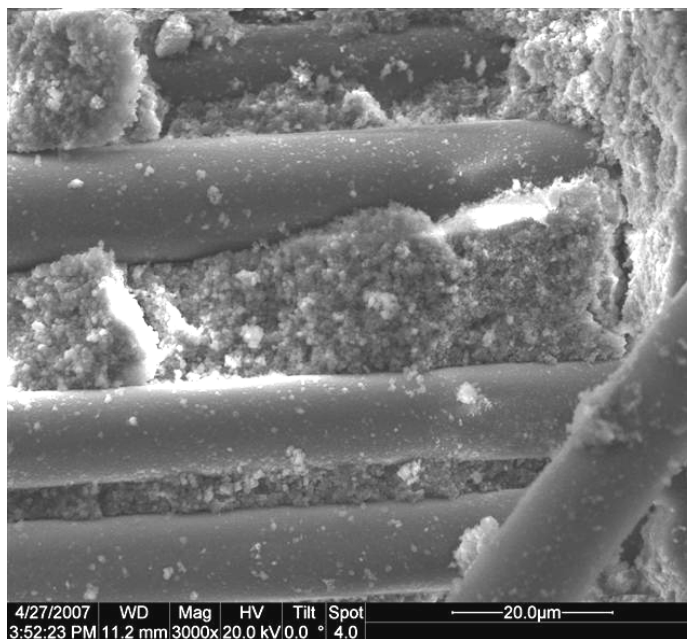
Figure 175: Fracture surface of the N720/A specimen not exposed to 1200°C.

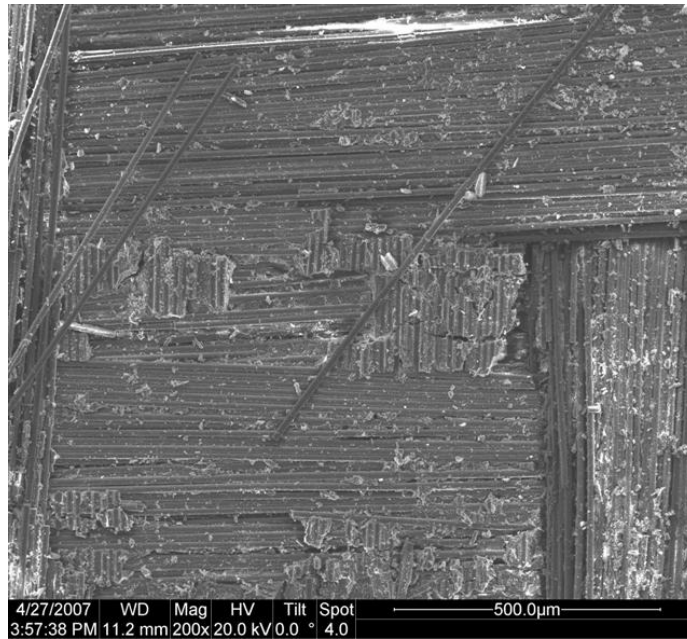
Figure 176: Fracture surface of the N720/A specimen not exposed to 1200°C.

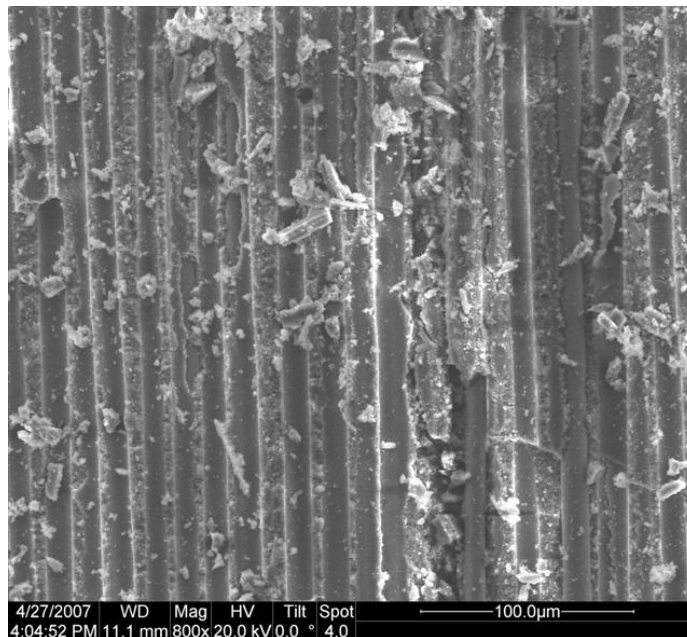
Figure 177: Fracture surface of the N720/A specimen not exposed to 1200°C.

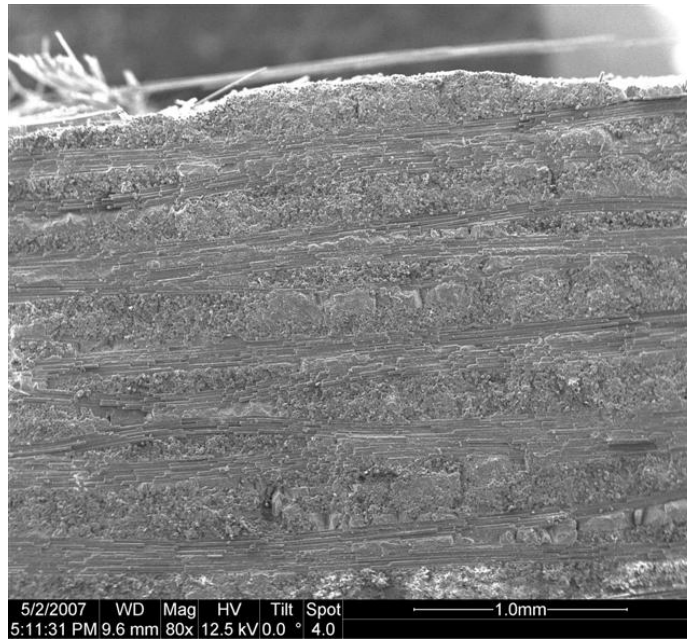
Figure 178: Side of the fracture surface of the N720/A specimen not exposed to 1200°C.

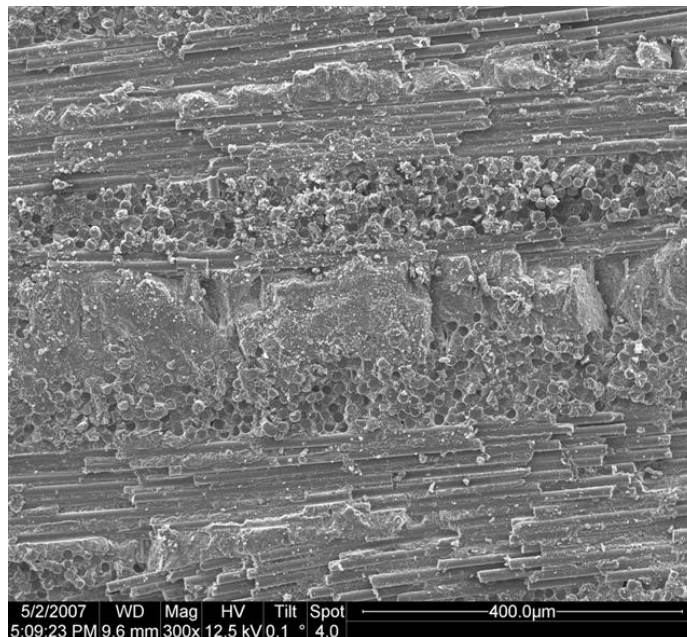
Figure 179: Side of the fracture surface of the N720/A specimen not exposed to 1200°C.

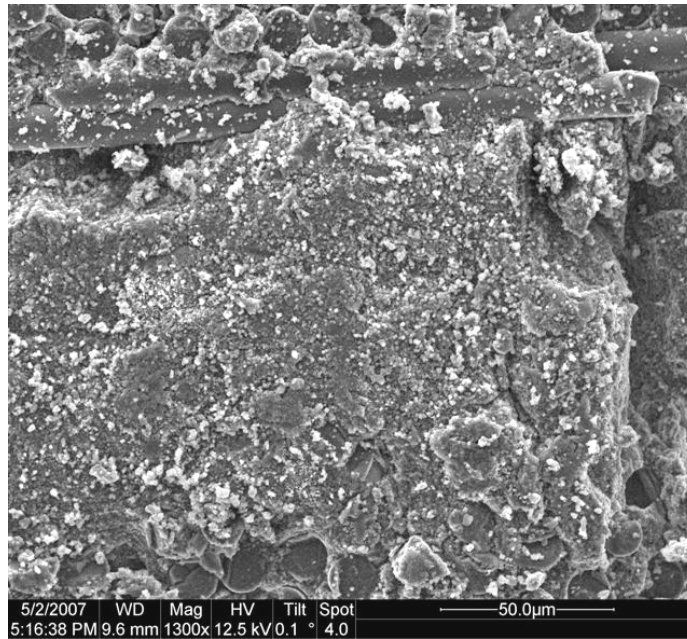
Figure 180: Side of the fracture surface of the N720/A specimen not exposed to 1200°C.

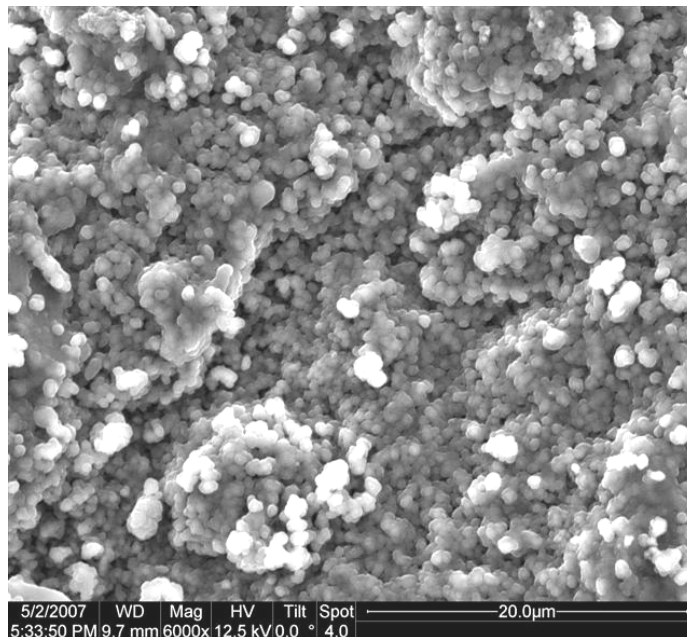
Figure 181: Side of the fracture surface of the N720/A specimen not exposed to 1200°C.

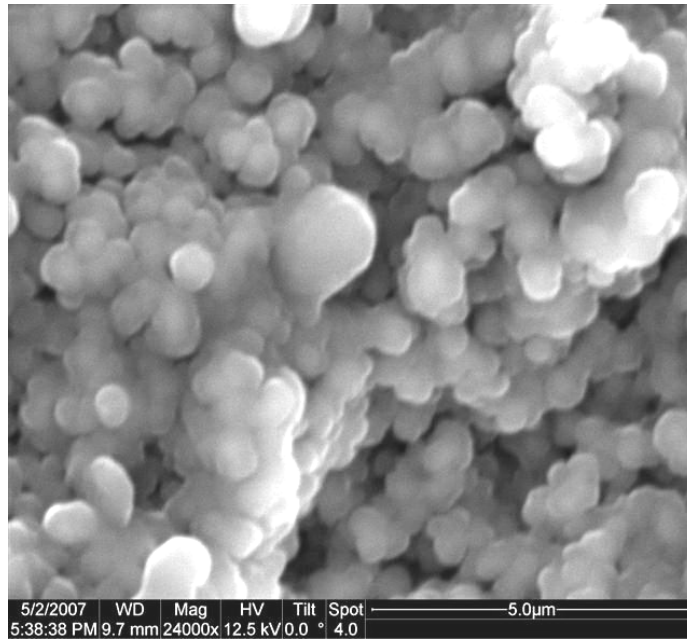
Figure 182: Side of the fracture surface of the N720/A specimen not exposed to 1200°C.

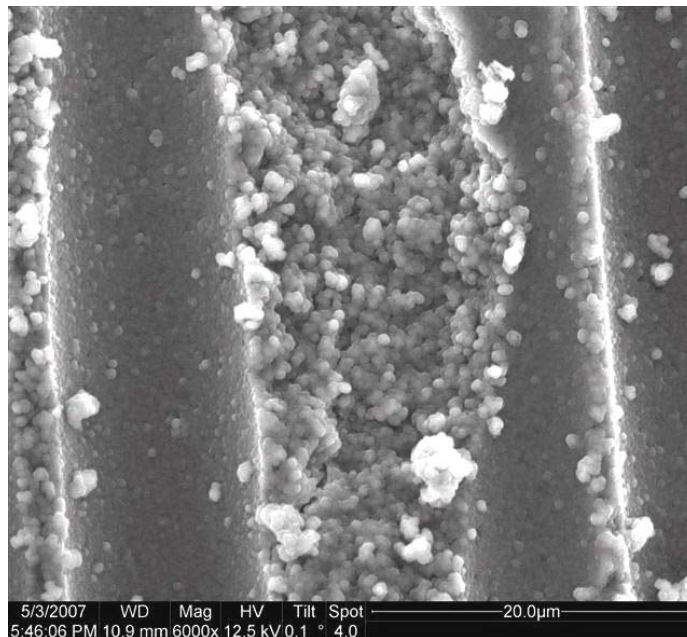
Figure 183: Fracture surface of the N720/A specimen not exposed to 1200°C.

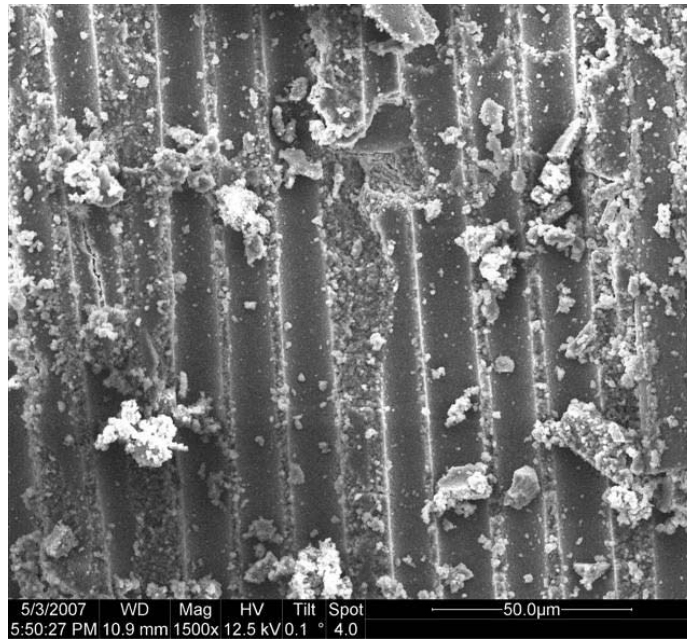
Figure 184: Fracture surface of the N720/A specimen not exposed to 1200°C.

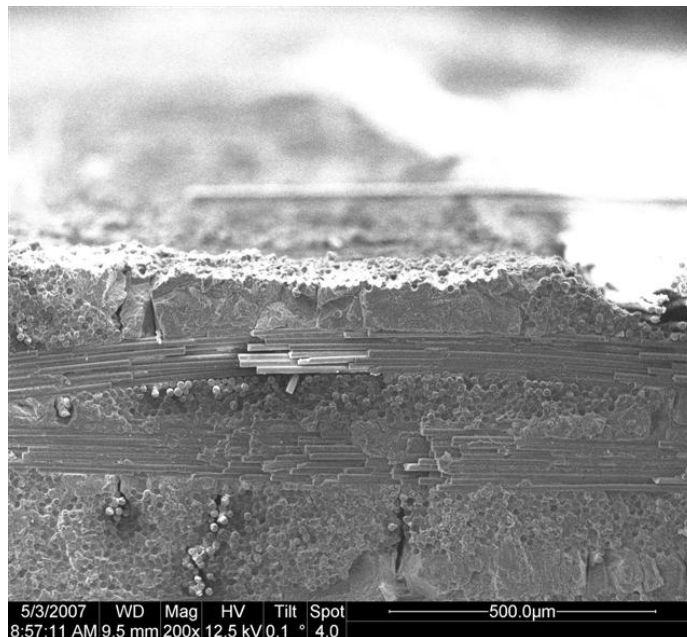
Figure 185: Side of the fracture surface of the N720/A specimen aged in steam at 1200°C for 24 h prior to compression to failure.

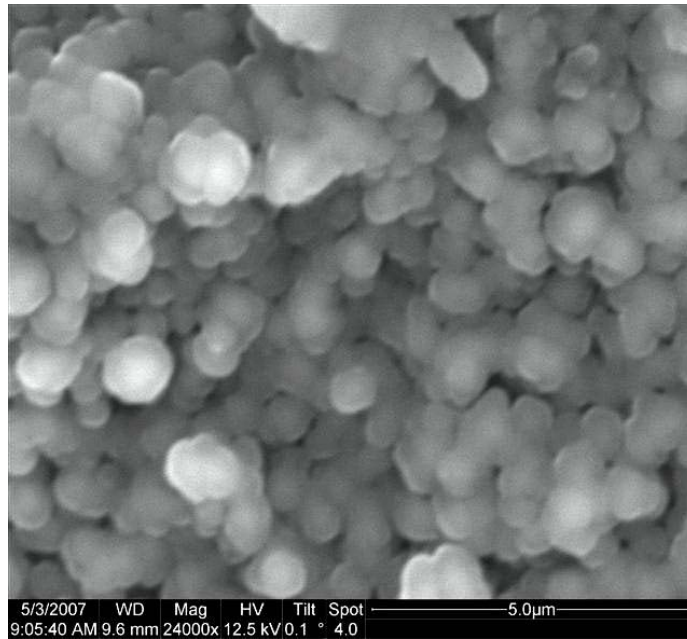
Figure 186: Side of the fracture surface of the N720/A specimen aged in steam at 1200°C for 24 h prior to compression to failure.

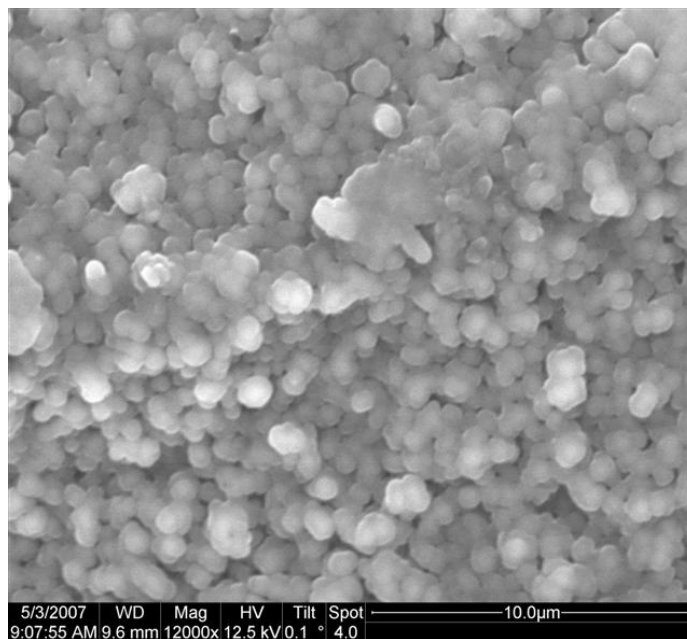
Figure 187: Side of the fracture surface of the N720/A specimen aged in steam at 1200°C for 24 h prior to compression to failure.

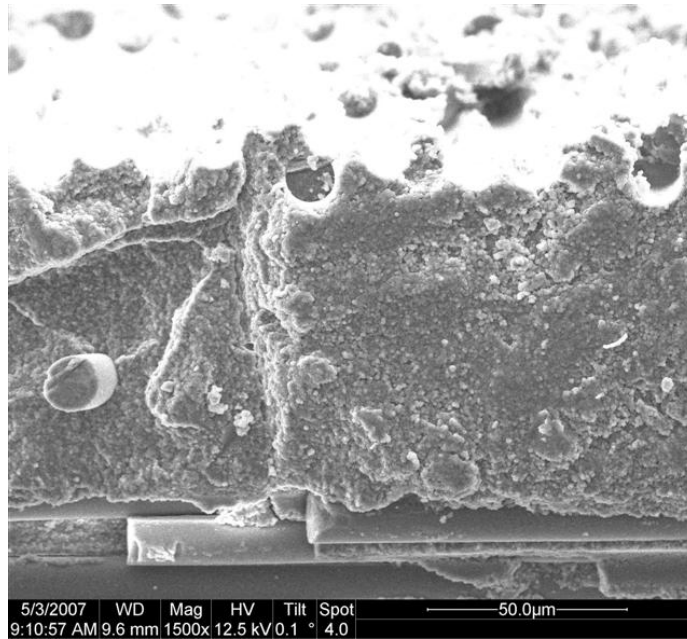
Figure 188: Side of the fracture surface of the N720/A specimen aged in steam at 1200°C for 24 h prior to compression to failure.

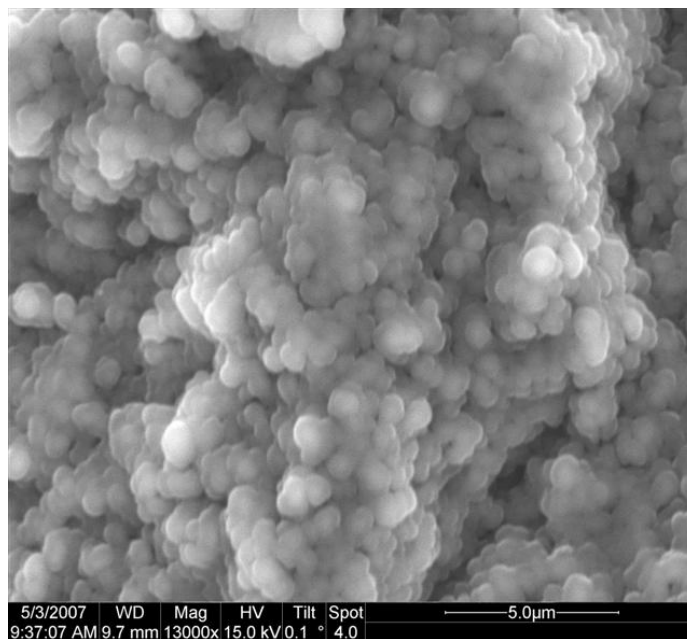
Figure 189: Side of the fracture surface of the N720/A specimen aged in steam at 1200°C for 24 h prior to compression to failure.

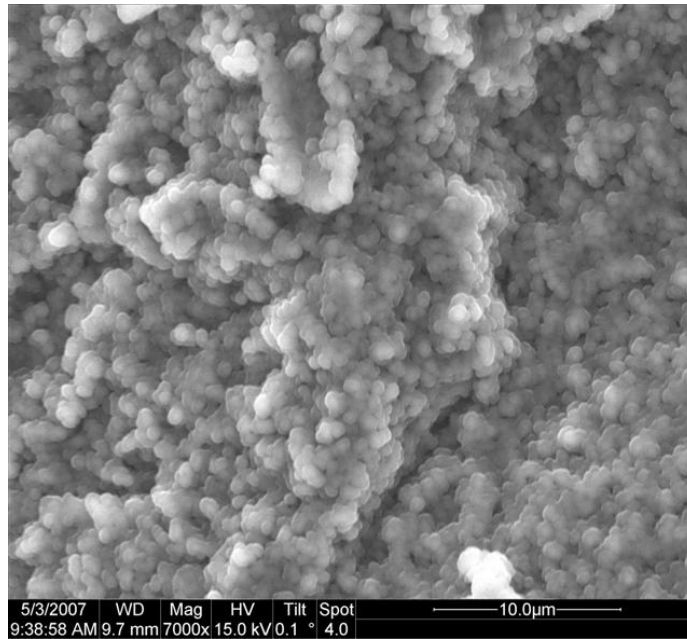
Figure 190: Side of the fracture surface of the N720/A specimen aged in steam at 1200°C for 24 h prior to compression to failure.

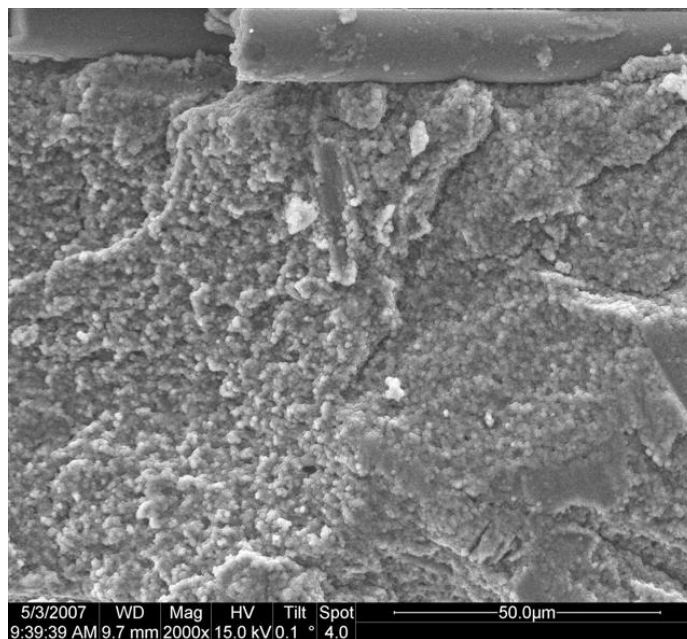
Figure 191: Side of the fracture surface of the N720/A specimen aged in steam at 1200°C for 24 h prior to compression to failure.

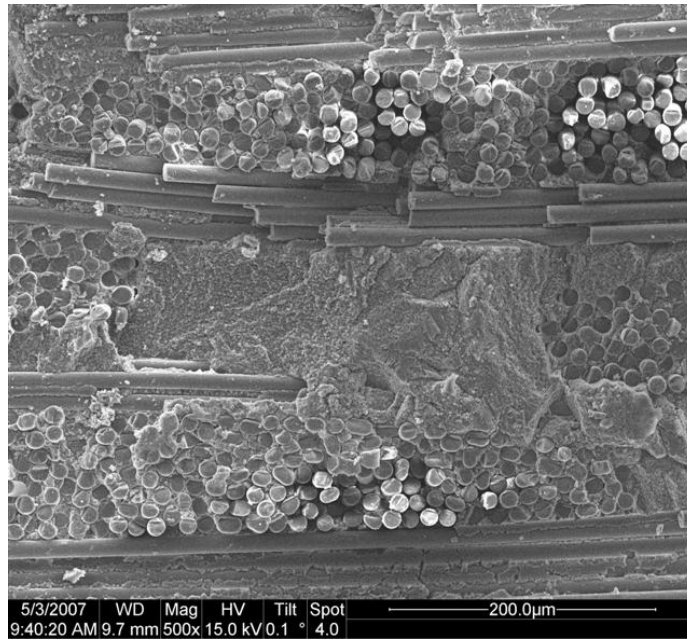
Figure 192: Side of the fracture surface of the N720/A specimen aged in steam at 1200°C for 24 h prior to compression to failure.

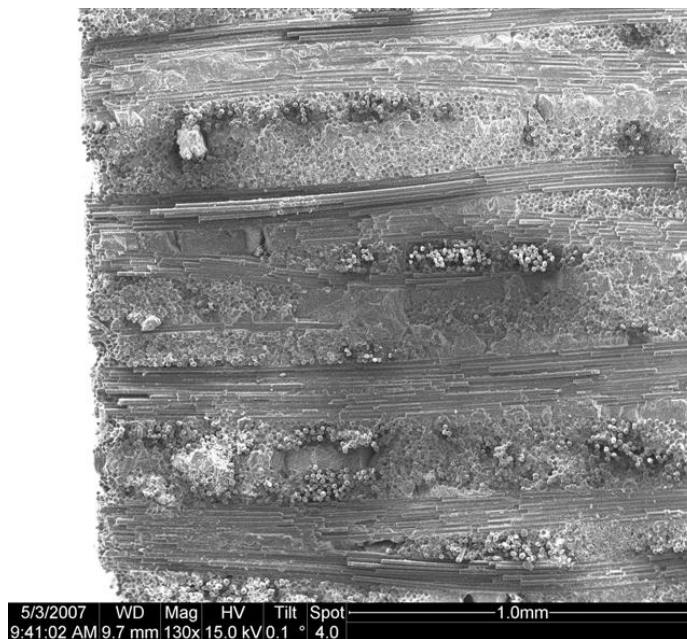
Figure 193: Side of the fracture surface of the N720/A specimen aged in steam at 1200°C for 24 h prior to compression to failure.

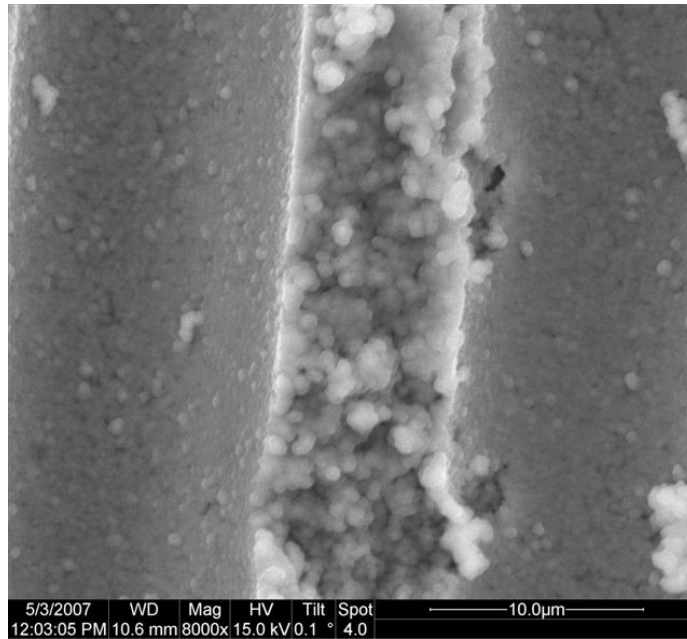
Figure 194: Fracture surface of the N720/A specimen aged in steam at 1200°C for 24 h prior to compression to failure.

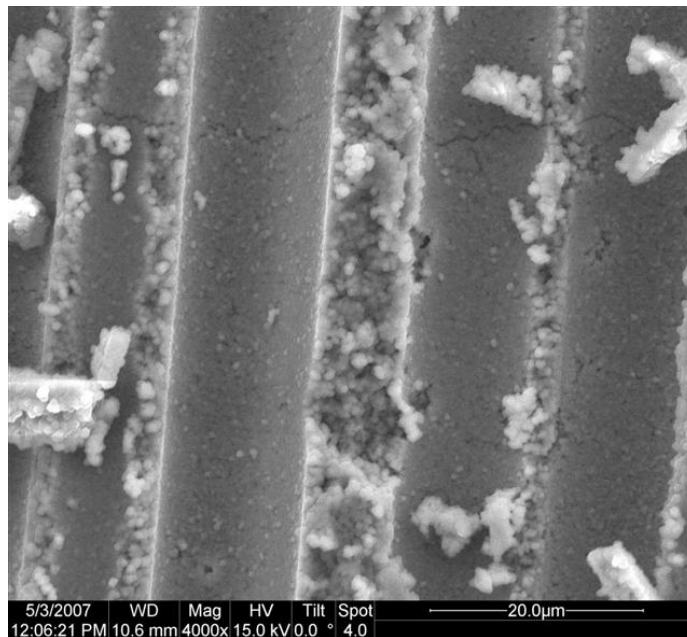
Figure 195: Fracture surface of the N720/A specimen aged in steam at 1200°C for 24 h prior to compression to failure.

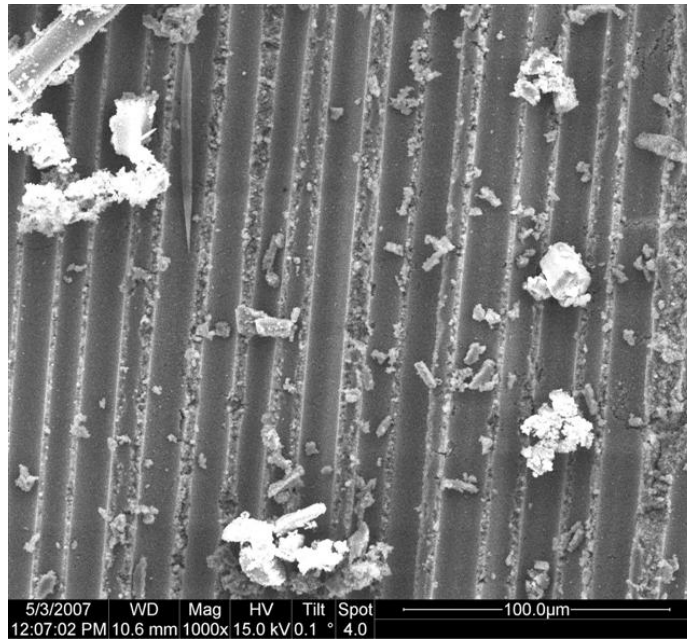
Figure 196: Fracture surface of the N720/A specimen aged in steam at 1200°C for 24 h prior to compression to failure.

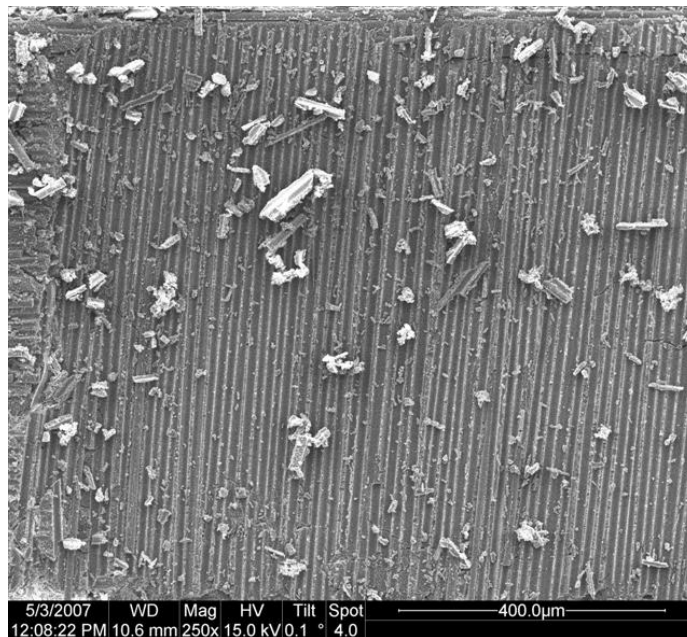
Figure 197: Fracture surface of the N720/A specimen aged in steam at 1200°C for 24 h prior to compression to failure.
